ND MIATA BRAKE COOLING KIT TESTING

A0114A INFORMATIVE PACKET

This is an informative packet on the Verus Engineering brake cooling kit, with information on testing and data gathering.

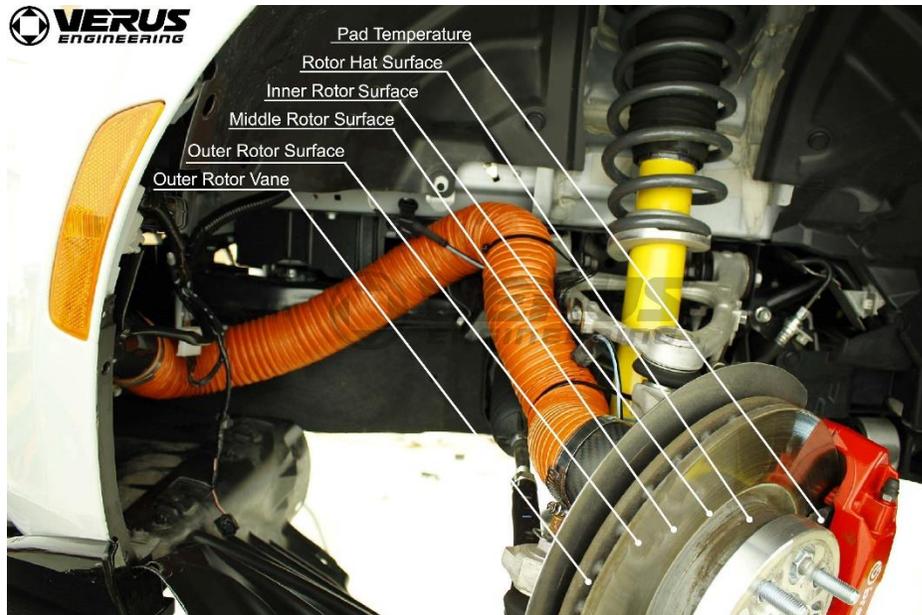
Digital Laser Infrared Thermometer

- **Accuracy:** +/- 1.5%
- **Scale:** -50 Deg. C to 380 Deg. C
- **Repeatability:** +/- 1 Deg. C
- Temperatures were taken at specific locations on the rotor/pads at a repeatable distance for accuracy.

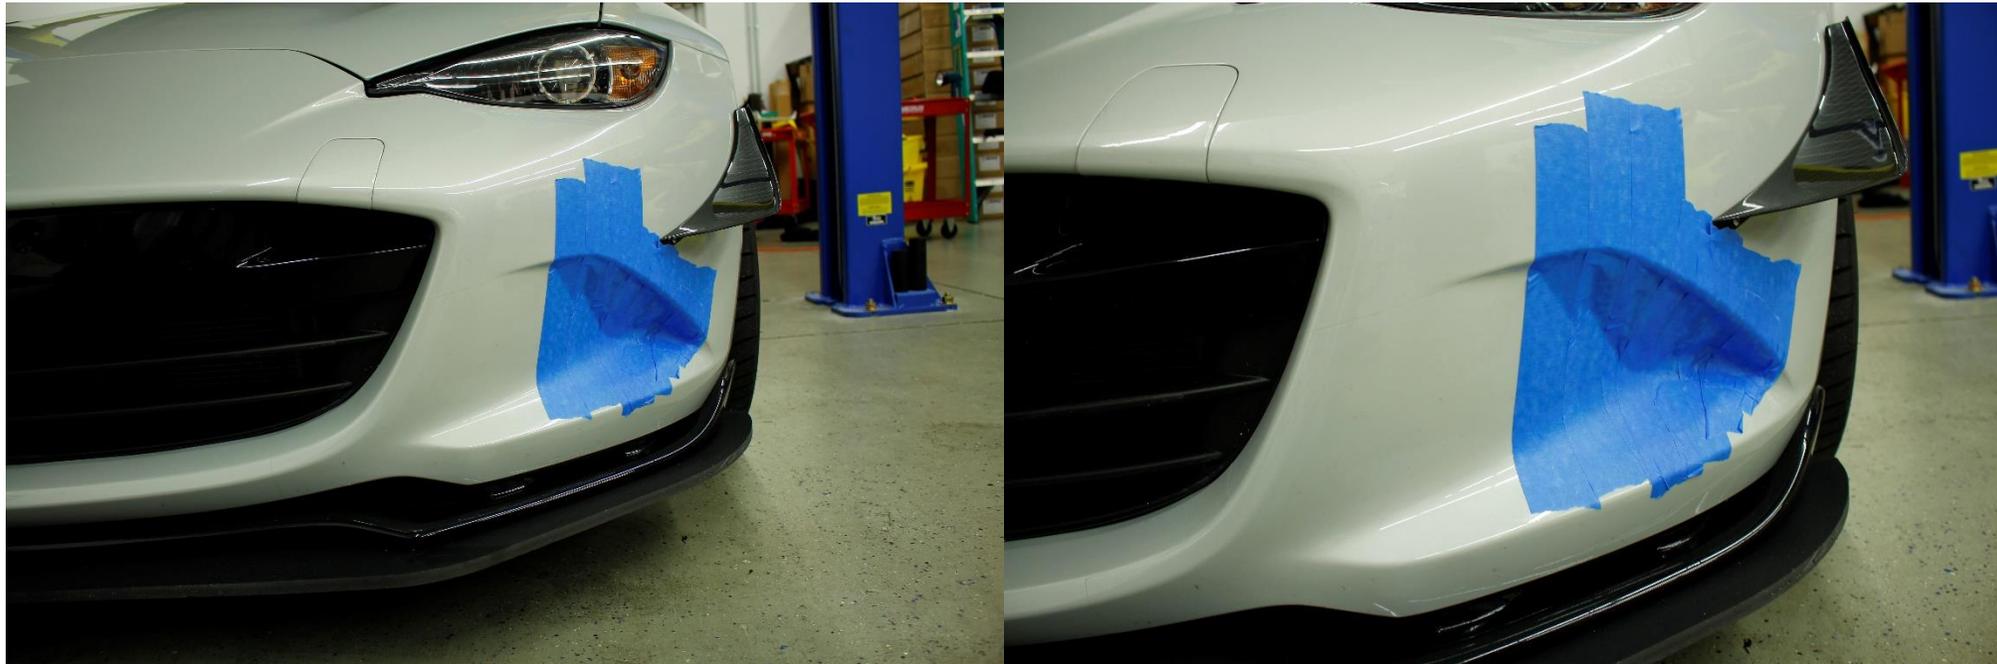
With the full brake cooling kit installed, we blocked off the fog light inlet on the driver's side of the vehicle and left the passenger side open. This allows us to test the difference between no cooling and cooling.

We tested the ND Miata brake cooling kit on a local backroad location we frequent. The speeds range from upwards of 60, down to 20; resulting in a decent bit of heat build up and not a lot of airflow. At higher rates of speed, we could expect to see larger temperature deltas between no-ducting and ducting as the cooling is related to airspeed.

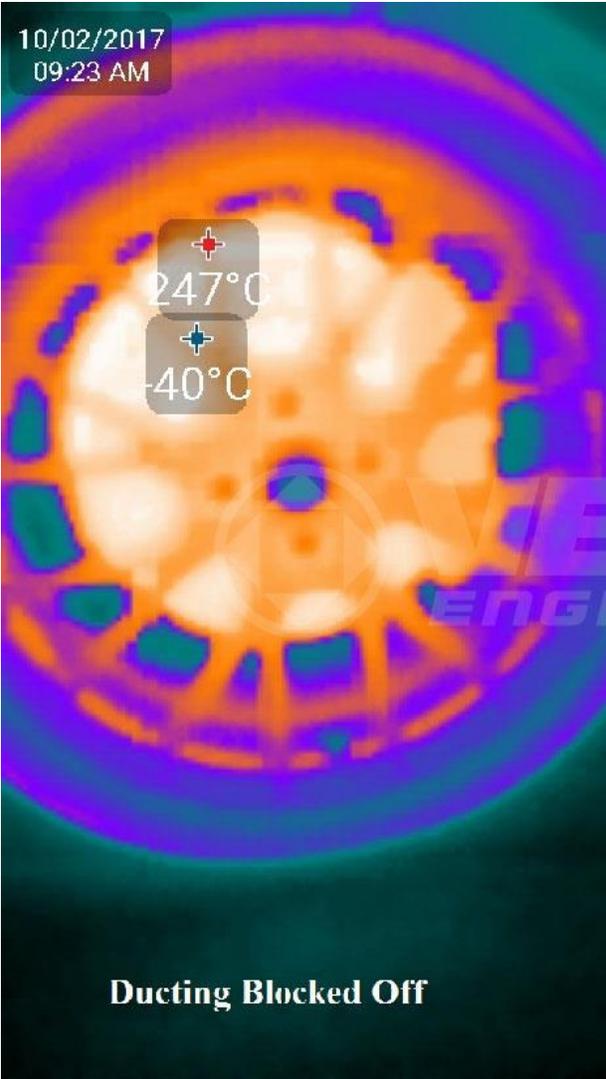
HOT TEST

Photo was taken directly after testing a hard braking event from 60MPH to 0.
